DEPARTMENT OF TRANSPORTATION

Contract #: 04-0120F4Cty: SF/ALA Rte: 80 PM: 13.2/13.9File #: 1.28**WELDING INSPECTION REPORT****Resident Engineer:**Siegenthaler, Peter**Address:** 333 Burma Road**City:** Oakland, CA 94607**Report No:** WIR-018592**Date Inspected:** 11-Dec-2010**Project Name:** SAS Superstructure**OSM Arrival Time:** 630**Prime Contractor:** American Bridge/Fluor Enterprises, a JV**OSM Departure Time:** 1500**Contractor:** American Bridge/Fluor Enterprises, a JV**Location:** Job Site**CWI Name:** See Below**CWI Present:** Yes No**Inspected CWI report:** Yes No N/A**Rod Oven in Use:** Yes No N/A**Electrode to specification:** Yes No N/A**Weld Procedures Followed:** Yes No N/A**Qualified Welders:** Yes No N/A**Verified Joint Fit-up:** Yes No N/A**Approved Drawings:** Yes No N/A**Approved WPS:** Yes No N/A**Delayed / Cancelled:** Yes No N/A**Bridge No:** 34-0006**Component:** Orthotropic Box Girders**Summary of Items Observed:**

WELDING INSPECTION REPORT

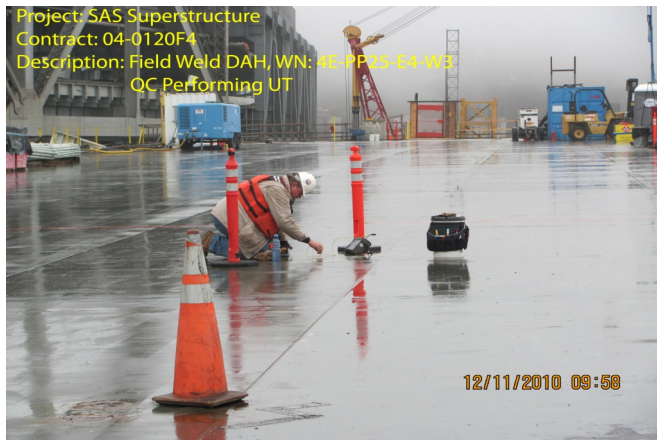
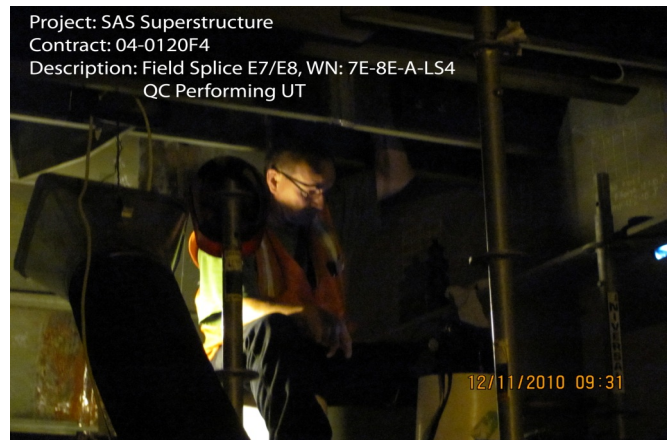
The digital photographs below illustrate the work observed during this scheduled shift.
